Flexco® Cracking Chisel

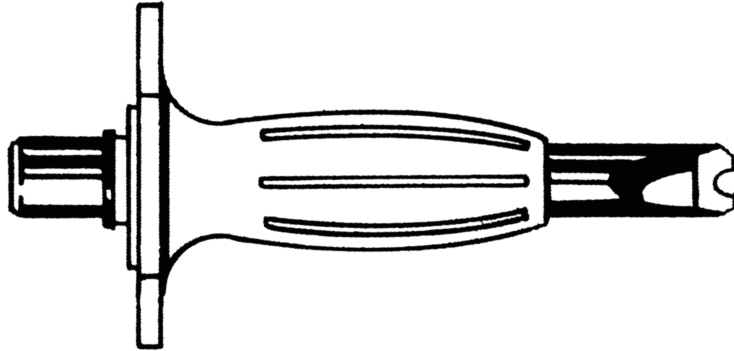
- Replacement of prematurely worn plates in minutes without replacing entire splice.
- Requires only a hammer.
- Three sizes available.
 - C1C for No. 1, 140 or 190 nuts
 - C2C for No. 1-1/4, 1-1/2, 2 or 2-1/4 nuts.
 - C3C for No. 2-1/2 and 3 nuts

With the new Flexco® Cracking Chisel, excessively worn top plates and individual fasteners can be replaced quickly and easily. Only a hammer and a Flexco® Cracking Chisel are required. Removal of prematurely worn plates avoids installing a complete new splice. Saves time and money. Two simple steps.

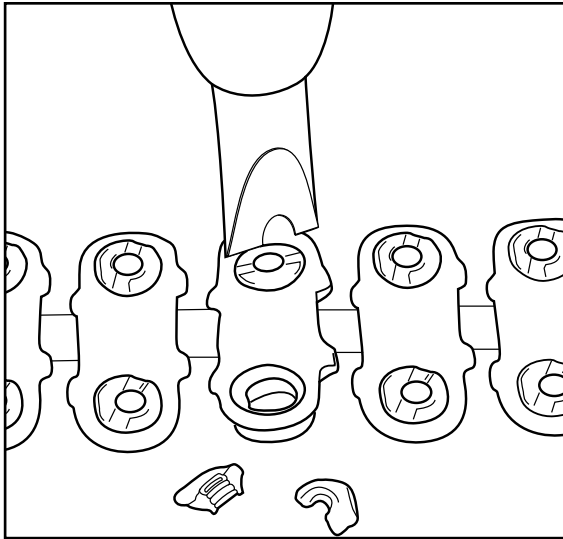
1. Place Cracking Chisel over the nut and hit with a firm blow. Use a 2 lb. or heavier hammer. Be sure to wear safety goggles. **NOTE:** Position worn plate over solid backing before striking chisel.

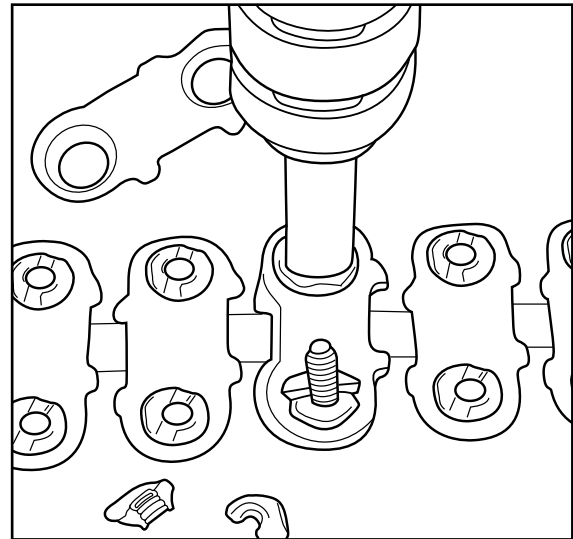
2. After nuts are removed, replace plates, bolts, and nuts. Tighten nuts and break off excessive bolt ends. **NOTE:** Tighten nuts so plates compress into belt cover and pucker belt around plate edge.
